AN EXCHANGE OF TECHNICAL INFORMATION
VOLUME 20 NUMBER 2 ABOUT CARRIER TRANSICOLD CONTAINER PRODUCTS **November 2014**

TechFact – “Mobile Friendly” Manuals

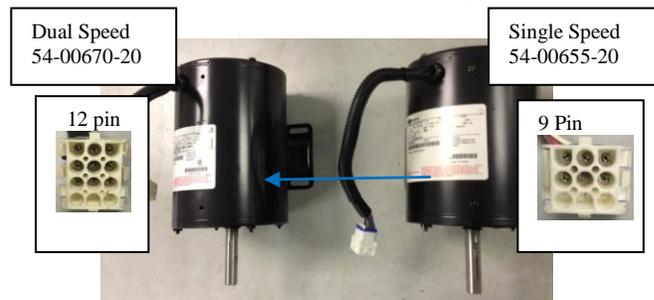
The following are installation instructions for installing a Three Phase Single Speed Condenser Motor into a 69NT40-561-3XX (PrimeLINE® EDGE) unit with a dual speed motor as an emergency when a direct replacement is not readily available.

1. From a failed CM (54-00670-20), cut the wires (150mm or 6”, measured from the 12 pin connector end) using a wire cutter and strip off (5mm or 0.2”) the wire insulation using a wire insulation stripper.
2. From the Emergency Replacement Motor (54-00655-20), cut the wires (150mm or 6”, measured from the 9 pin connector) using a wire cutter, and strip off (5mm or 0.2”) of the wire insulation from the motor end using a wire insulation stripper.
3. Position the heat shrink and crimp the electrical splice connector for all 6 replacement motor wires.
4. From the 12 pin electrical connector in step #1, perform the butt splice connection as shown below.

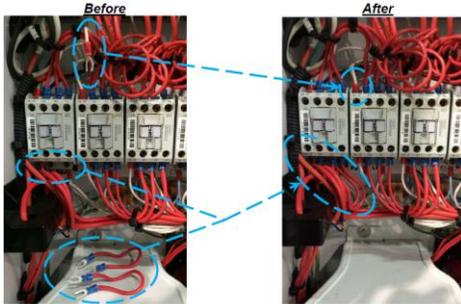
Recovery Procedures (Print and paste this page in front of control box): **For emergency repair, this unit has been modified to use a Condenser Motor (CTD# 54-00655-20) as the actual replacement Condenser Motor (CTD# 54-00670-20) is not available. With this modification, unit is expected to fail PTI P2-0 (condenser fan low speed test). The correct replacement Condenser Motor (CTD# 54-00670-20) should be installed onto this unit at the earliest opportunity.**

2. On LC Contactor (Contact 22), re-connect the white wire marked “FSA1~LC22” to the LC Contactor.
3. On FS Contactor (Contact L1, L2, L3), replace the 2 jumper red wire from the FS Contactor (L1, L2, L3), i.e. Jumper L1 to L2, and L2 to L3, reference to electrical schematics if necessary.
