# AN EXCHANGE OF TECHNICAL INFORMATION VOLUME 18 NUMBER 2 ABOUT CARRIER TRANSICOLD CONTAINER PRODUCTS November 2012

TechFact - Alarm 24 Scroll Compressor IP

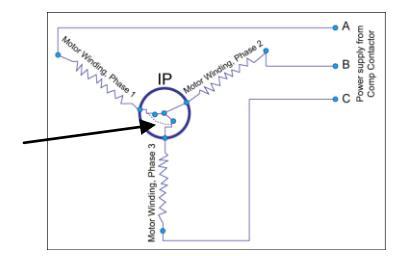
In the EliteLINE® (EL) & PrimeLINE® (PL) units' scroll compressors, Carrier Transicold uses a 3-phase Internal Protector (IP) embedded in the compressor motor winding that opens two of three high voltage power supply connections to stop the motor when it over- heats. The connections are located at the wye connection within the compressor motor winding.

With this, the EL & PL units have different alarm logic than the ThinLINE® unit (TL), where the compressor IP is easily identified on the schematic as part of the compressor's low voltage circuit.

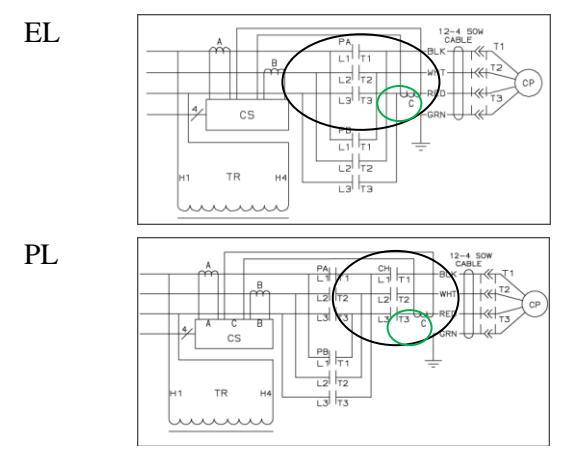
Unlike the TL unit that uses a current sensor with only two sensing outputs, the scroll units (EL & PL), have three sensing output current sensors where the third current sensor is located downstream of the compressor contactor and senses the  $3^{rd} leg / Phase C$  of the compressor (Green circle in the below sketch).

When the compressor contactor is energized and there is no current, the microprocessor senses that the IP is open. The alarm condition will be checked every 5 minutes and will go inactive once current is sensed.

When troubleshooting the AL 24, ensure the current sensor and the compressor contactor are trouble free, as they will also prevent the compressor's third leg from drawing amperage.

To confirm an open IP, lock out / tag out the unit and ohm between each leg of the compressor at the compressor contactor (PA for EL and CH for PL). An open circuit measured here is an indication of an actual open compressor IP.
