Inside This Issue

TechTips

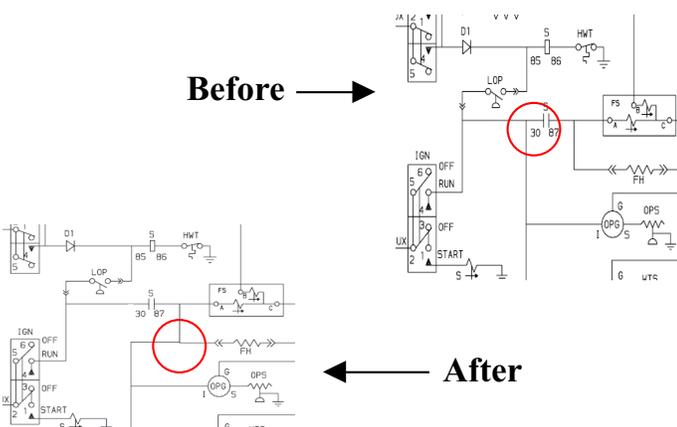
Hour Meters – Change the 12 volt hour meters from continuing to clock time if the unit was to run out of fuel and or the start switch left in the RUN position to operating only when the engine is operating.

This will place the hour meter on the load side of the safety relay preventing the continuous running of the hour meter.

1. Removing the S30-OPGI wire from the S30-IGN4 wire on the S30 terminal on the safety relay.
2. Perform a 2 to 1 butt splice with the S87-FHB wire.
