AN EXCHANGE OF TECHNICAL INFORMATION

VOLUME 19 NUMBER 1 ABOUT CARRIER TRANSCOLD CONTAINER PRODUCTS

June 2013

TechFact – NEW Look to the ThinLINE® and PrimeLINE® units.

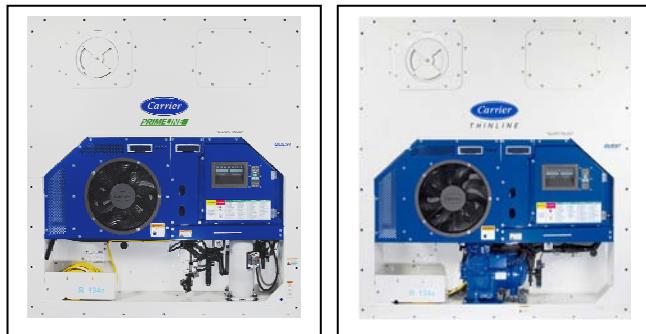
PrimeLINE models 561-2xx and greater along with ThinLINE models 541-5xx and greater have a new look (shown below), which is the result of our continuous drive to improve efficiency while also reducing overall weight and improving serviceability.

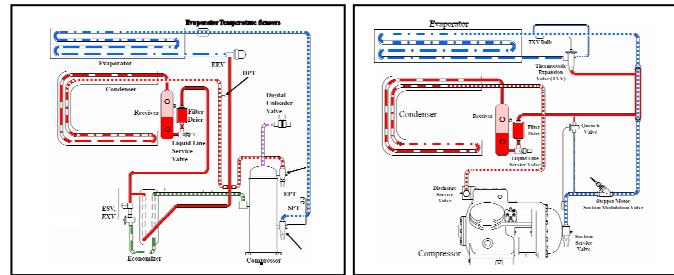
(See Refrigerant Flow, addendum number 1)

With this new look the refrigeration cycle remains the same as the previous PrimeLINE and ThinLINE units.

Updates primarily consist in either the relocation of hardware and/or the standardization of hardware used.

Following is a listing of the key changes:

Condenser Coil – Changed from a flat, 7 mm coil to a C shaped 7mm 2 row coil (coil p/n 81-04203-20).

Condenser Motor – Changed from single to three phase (p/n 54-00655-20, fan blade p/n 38-00620-01).

Receiver Tank and Filter Drier – Moved from under the condenser coil to next to the condenser coil (PL p/n 79-04049-00, TL p/n - 01).

Control Box Door – The unit display and the keypad are installed on the door. Door now opens outward from the unit. Door, less keypad and display, is part number 79-04018-00 w/Philips screws, -01 w/ Latches).

Evaporator Coil – Changed from inward sloped to an outward sloped coil. (p/n 81-04186-20).

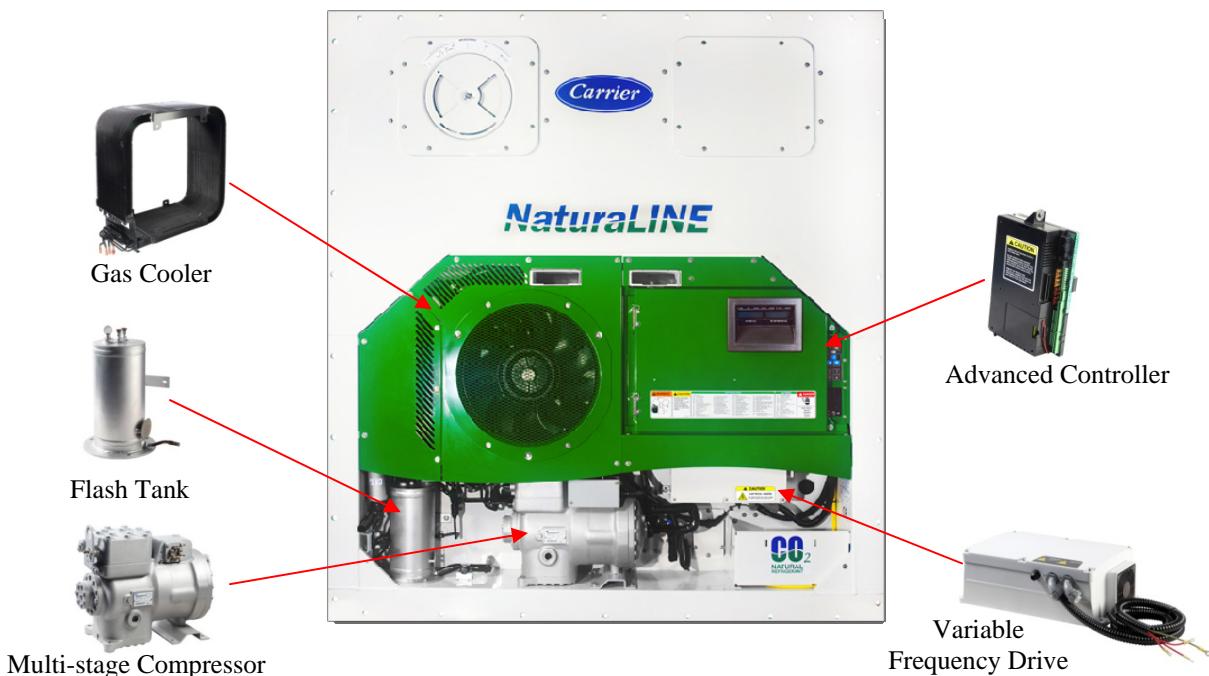
Structural Overview

The following machinery changes were incorporated into the NaturaLINE unit:

- Two-speed fans for the evaporator and gas cooler.
- A new multi-stage reciprocating compressor.
- The electric motor that powers the compressor runs at variable speeds. A custom-designed variable-speed drive electronically adjusts the compressor's speed, to provide the precise amount of cooling capacity to meet demand.
- A gas cooler coil that wraps around the fan, maximizing heat-transfer surface area for greater efficiency in a design that is both compact and lightweight.
- A flash tank, which manages the flow and phase change of the refrigerant.
- The operating software has been reengineered to manage the unique NaturaLINE mechanical system while still providing an easy-to-use control interface that works virtually the same way as every other Carrier container refrigeration unit.

During start up, valves are opened to allow for equalization of system pressures. As the start up procedure transitions to control mode, the evaporator and gas cooler fans are cycled on, the electronic expansion valve (EEV) is energized, and the compressor and variable frequency drive (VFD) are ramped up.

During normal operation, temperature control is maintained by VFD speed, system pressures and superheat control and cycling of the gas cooler fan. All of these variables are monitored and controlled by the microprocessor using the new enhanced software. System pressures are controlled by the positioning of the high pressure expansion valve (HPXV), EEV, compressor speed, and opening and closing of the economizer solenoid valve (ESV) or unloader solenoid valve (USV). System pressures are monitored by the suction pressure transducer, the high side pressure transducer and the flash tank pressure transducer.

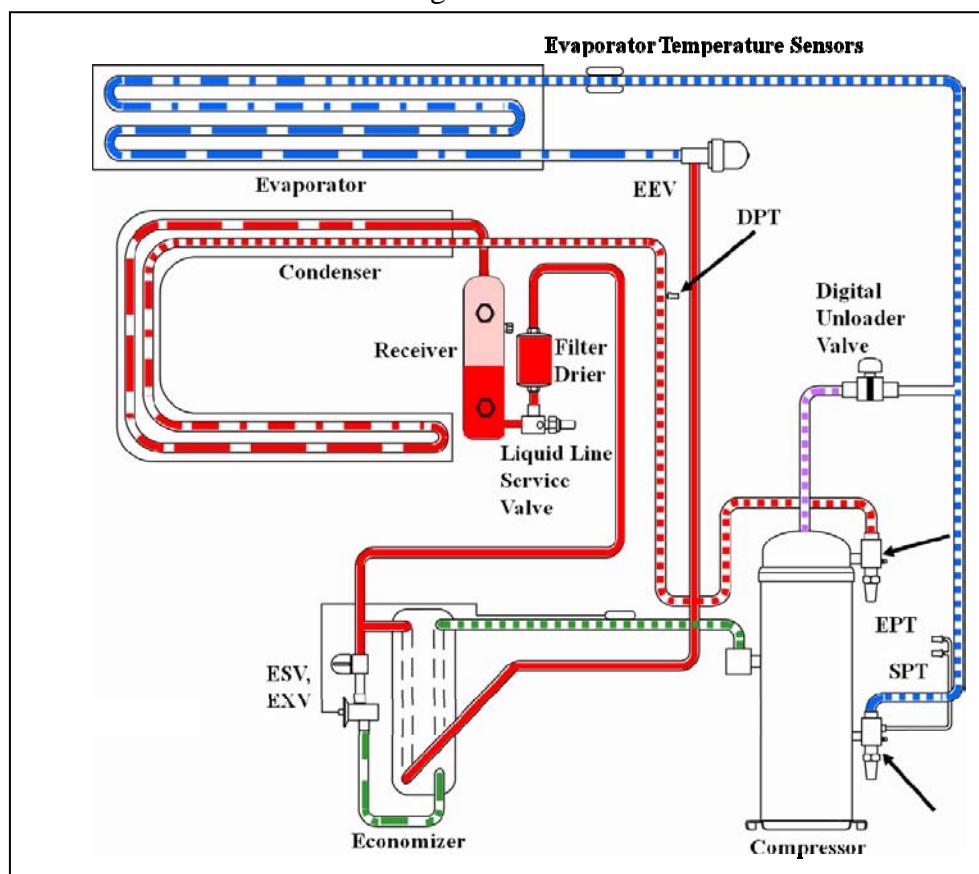
PrimeLINE®: Model 69NT40-551-2XX and greater

Refrigerant Flow (Addendum 1)

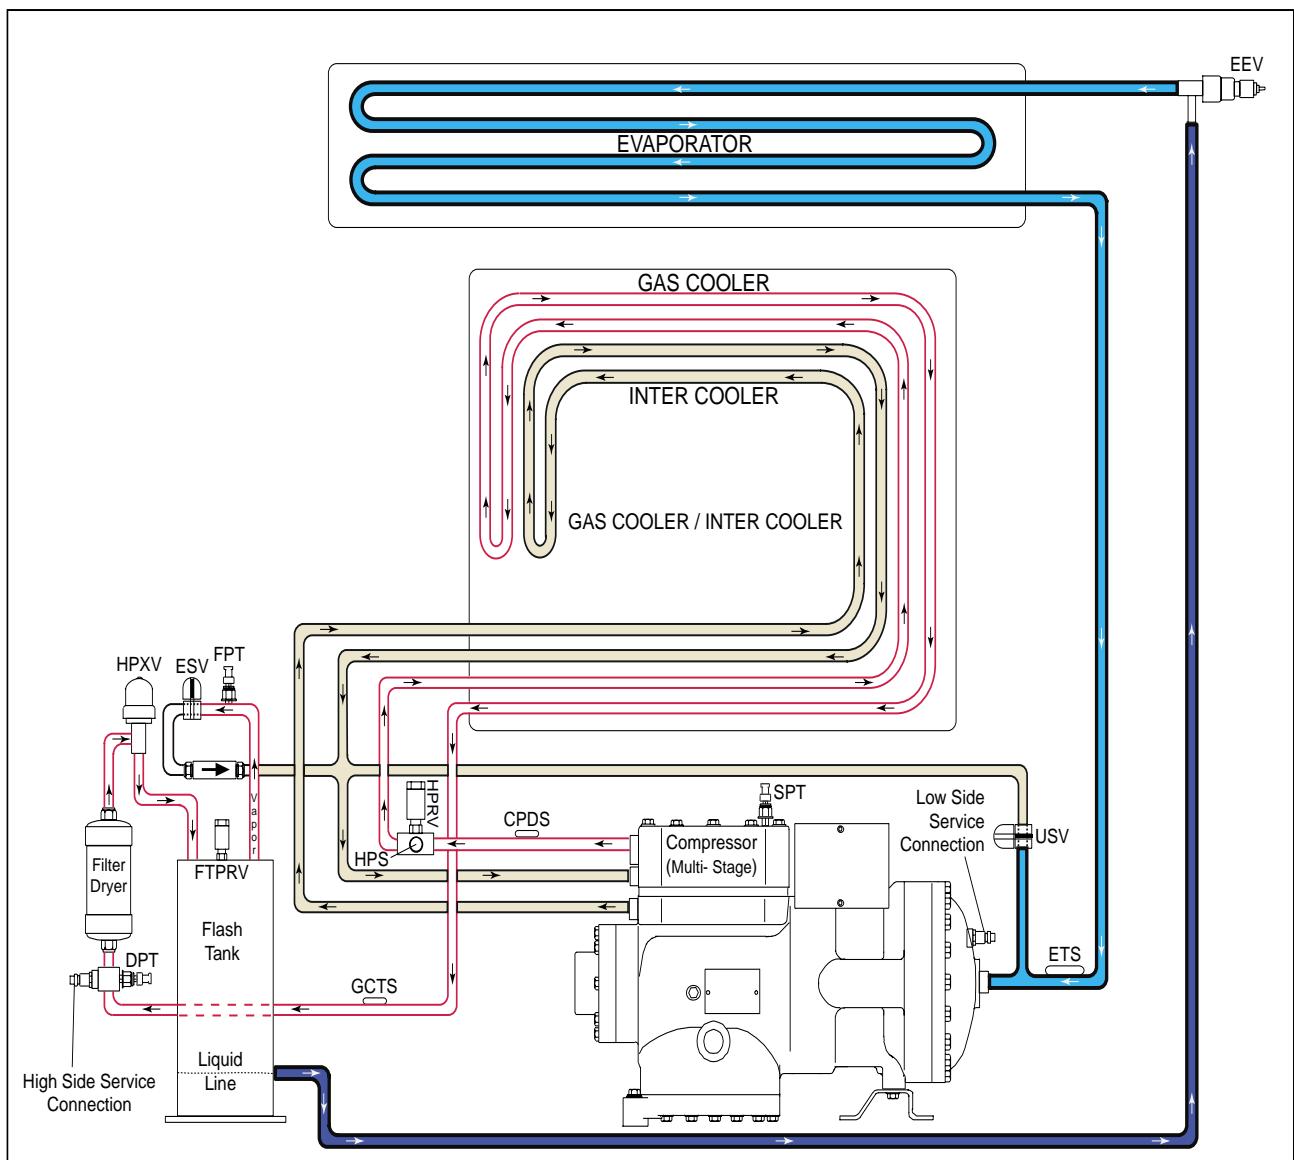
NaturaLINE™: Model 69NT40-601-XXX and greater

Refrigerant Flow (Addendum 2)

(See Refrigerant Flow, addendum number 2)
